STUDY OF BEHAVIOR OF GRILLAGES IN ELASTIC AND PLASTIC RANGES

FINAL REPORT

Contract No. N00024-67-C-5356
Project Serial No. S-F013 C3 01 Task 2050
SwRI Project No. 03-2101-01

for
Naval Ship Systems Command
Department of the Navy
Washington, D. C. 20360

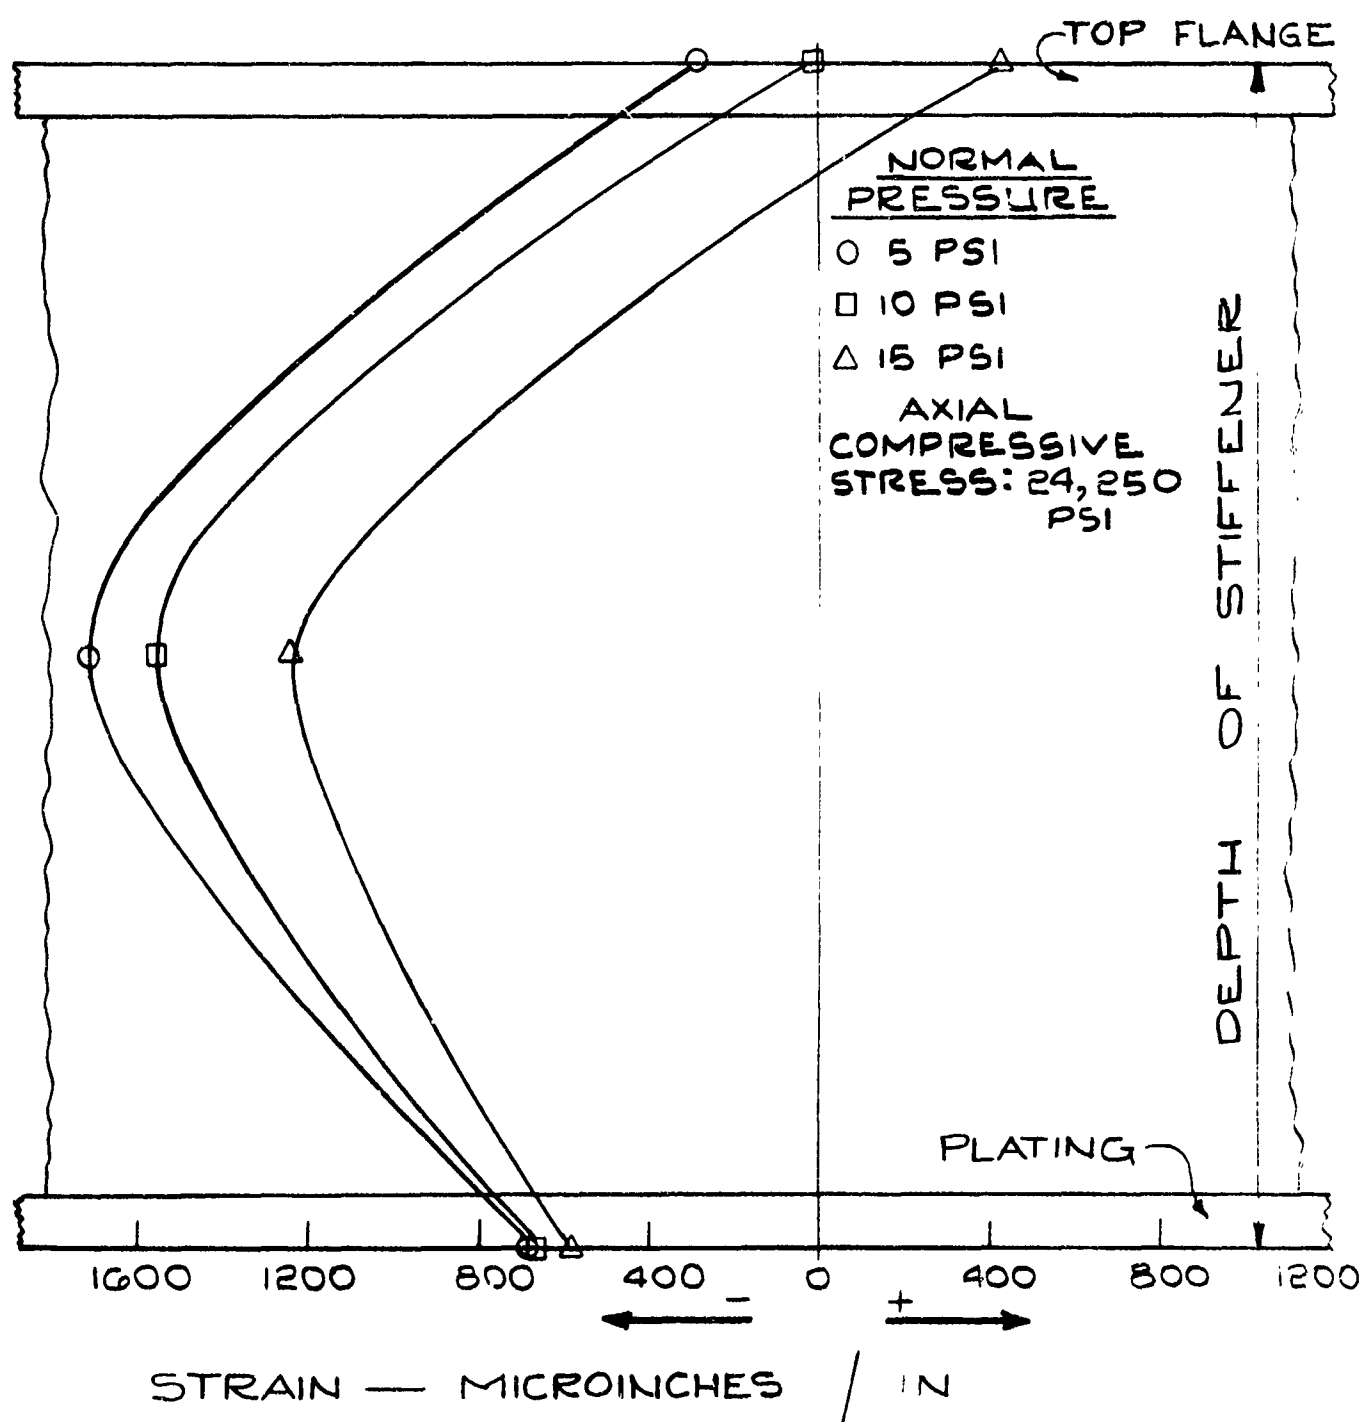
FIGURE 22(b). LONGITUDINAL STRAIN, ϵ_x , IN LONGITUDINAL "A" 18" FROM THE CENTRAL TRANSVERSAL

Figure 22(a) gives the strain distribution in the grillage longitudinals at the axial stress of 24,250 psi. It will be noted that the strains in the top flange of the longitudinal have changed little from their corresponding values in Figure 21. The strains in the "bottom flange," however, have increased noticeably. Again, at the maximum pressure of 15 psi the strain distribution is linear (almost perfectly linear in this case), with the geometric center of the section experiencing zero strain.

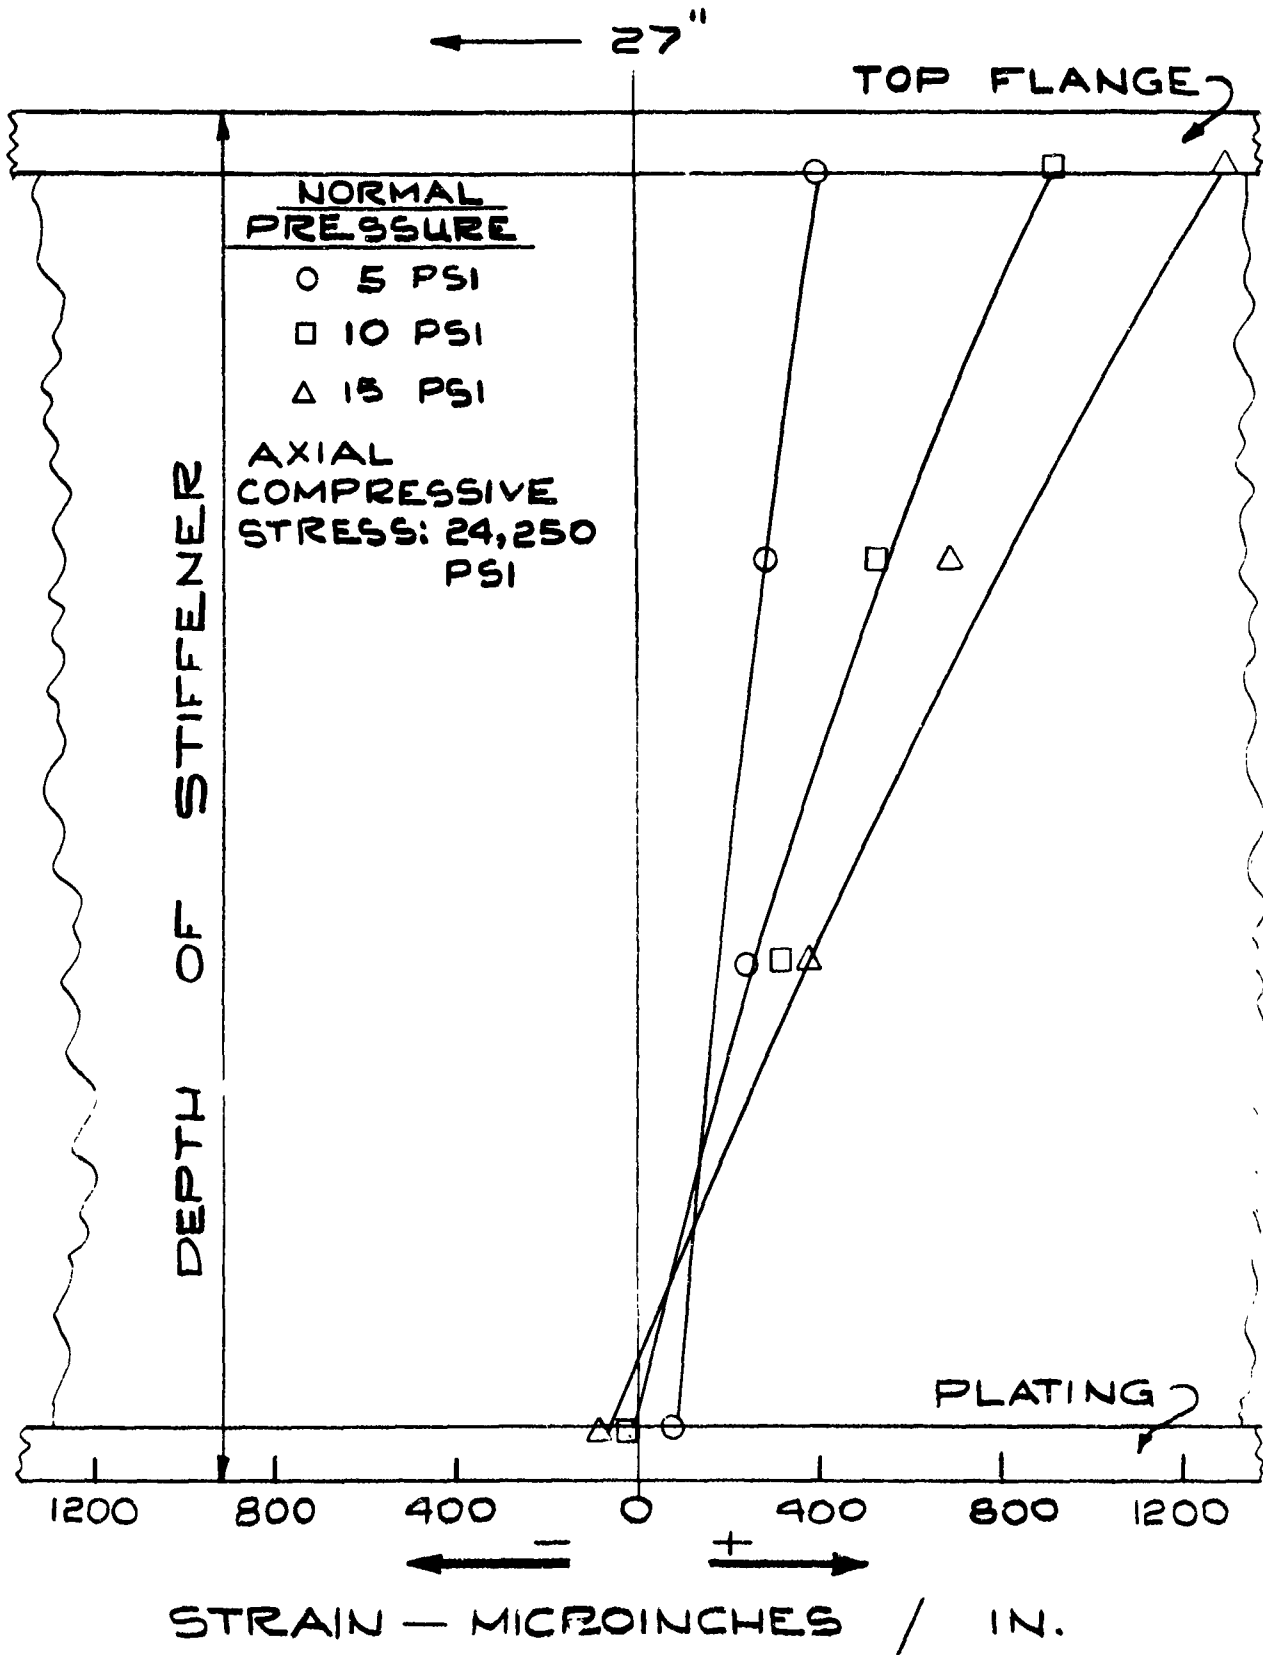
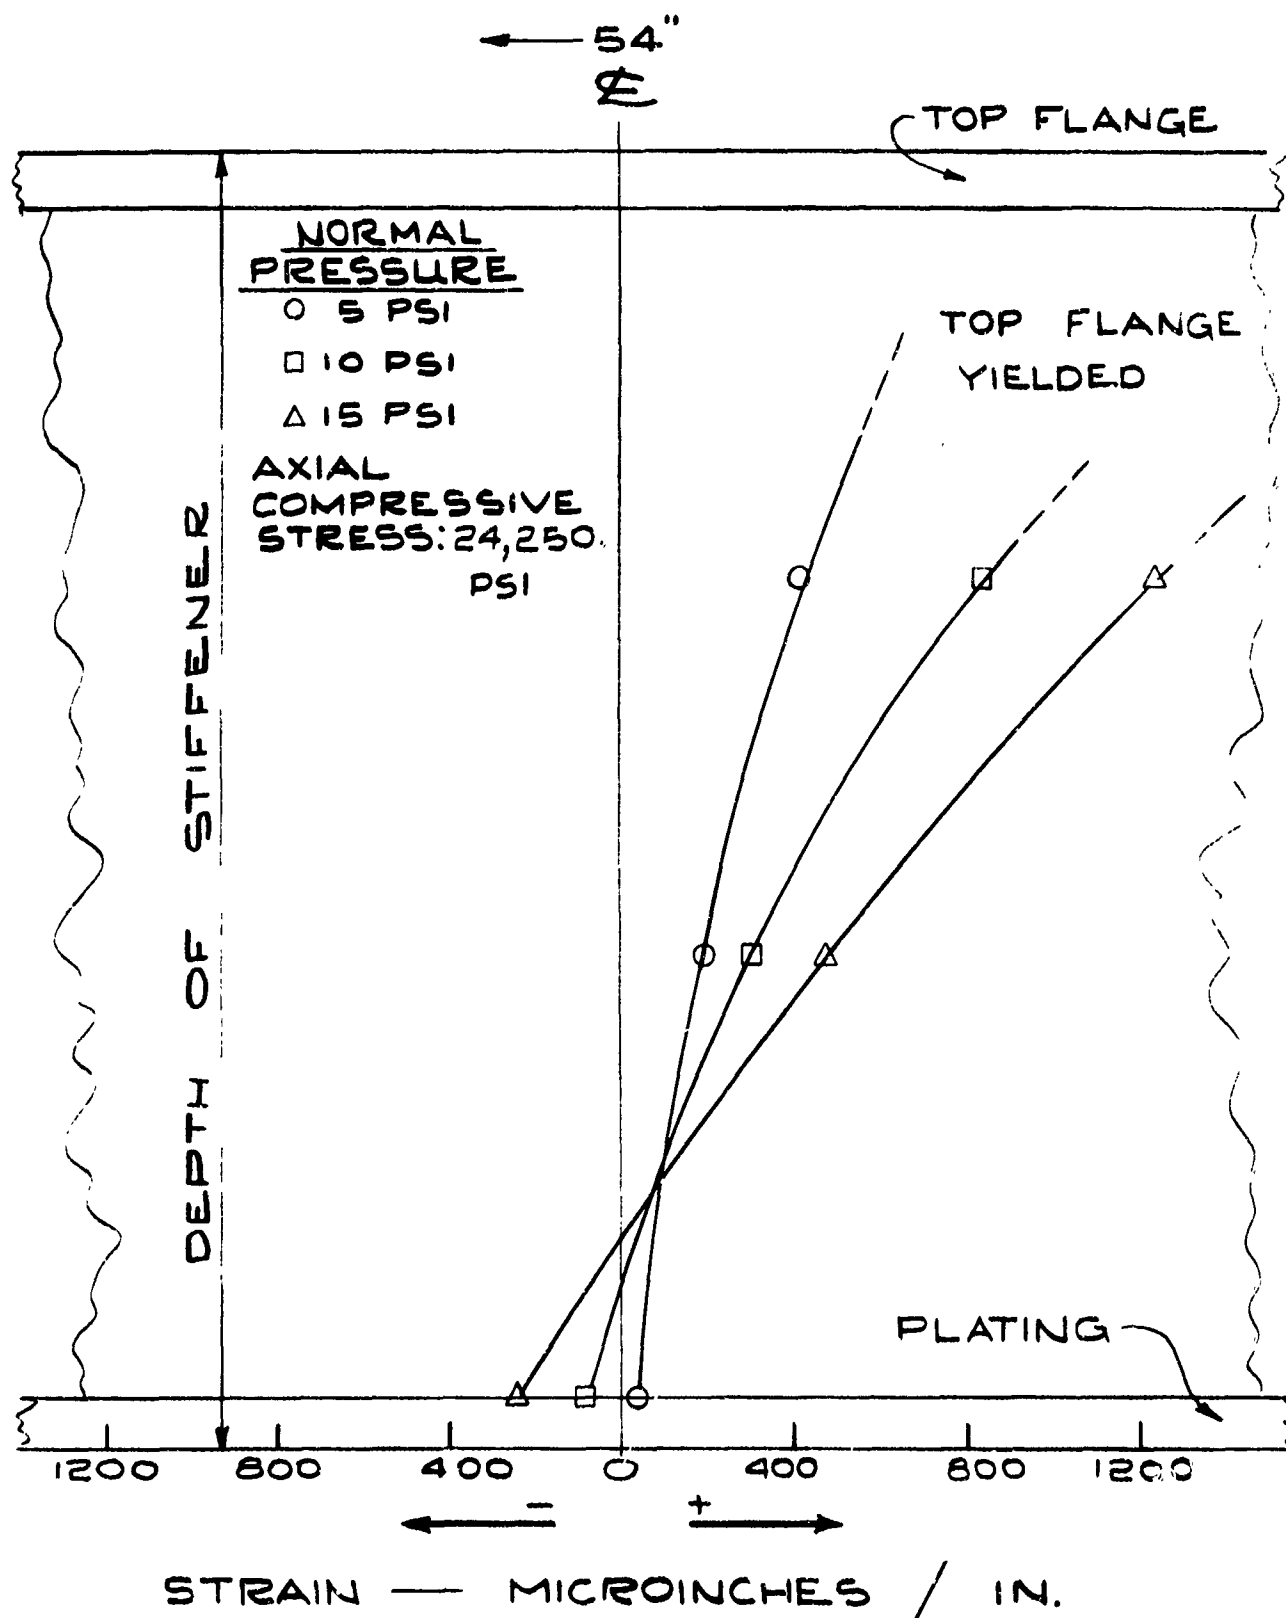
FIGURE 24(a). STRAINS IN THE CENTRAL TRANSVERSAL 27" FROM THE GRILLAGE EDGE

FIGURE 24(b). STRAINS IN THE CENTRAL TRANSVERSAL AT THE GRILLAGE CENTERLINE

The strains at various sections along the central transverse stiffener are given in Figures 23 and 24. Strains 7 inches from the side of the grillage could not be plotted with any accuracy because, apparently, there was considerable strain concentration at this section and the resultant strain records were unsatisfactory.

It will be noted that both at 17,750 psi and 24,250 psi axial stress, the strain distribution was nearly linear 27 inches from side of grillage

and, at low pressures, this linearly was maintained to the longitudinal centerline of the grillage. Moreover, at all pressures, the zero strain axis is close to the bottom plating. This shows that the effective width of plating is virtually unaffected by either the axial load or the normal pressure. Thus, the behavior of transversals, because of the absence of axial loads, is quite different from that of the longitudinals.

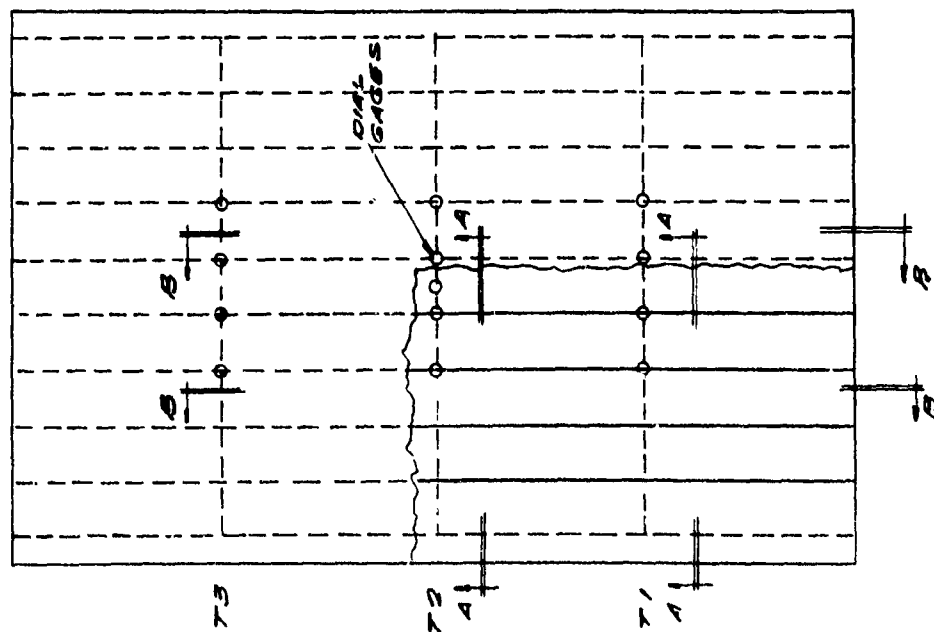
FIGURE 25(b). STRAIN GAGE KEY
